UI Bulletin #167b

Subject:	HD Pickup Box Removal / ZW9 Capped Fuel Filler Assembly Components
Models:	Chevrolet Silverado/GMC Sierra Heavy Duty Pickup – 56" CA `Long Box'
Model Years:	2020 and Beyond
Date:	May 14, 2020
Revision Date	N/A

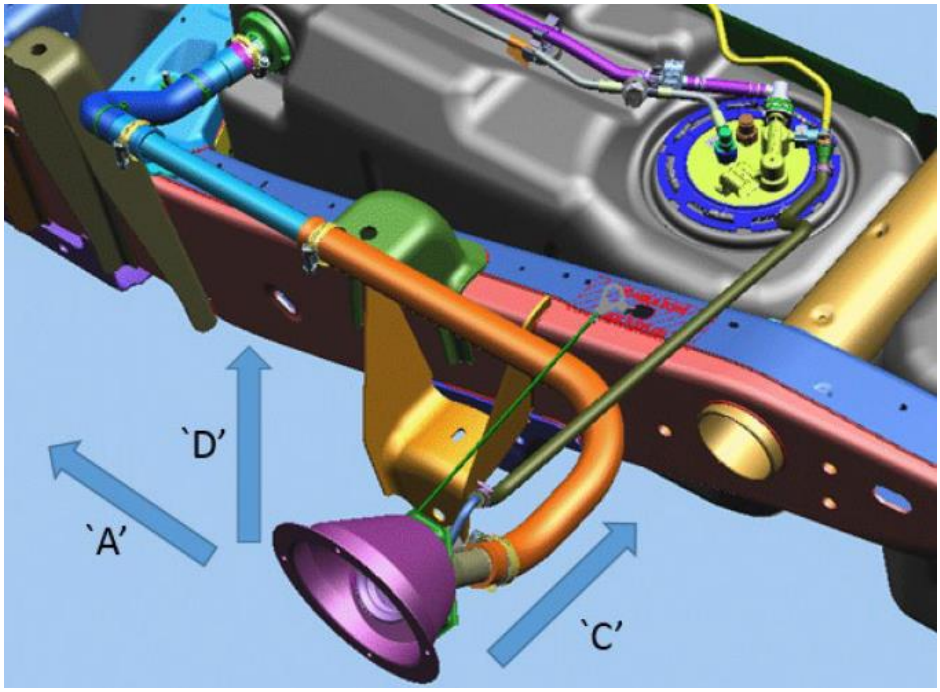
GAS PU Box Removal' GM Service Parts

84709155 HD Pickup ZW9 `GAS'(FJW) Fuel Fill Assembly (above)

Upfitters should use the following combination of approved RPO- ZW9 Fuel Filler Components for completing `Pickup Box Removal' upfit applications:

GAS (FJW) -*Shown on Page 2*

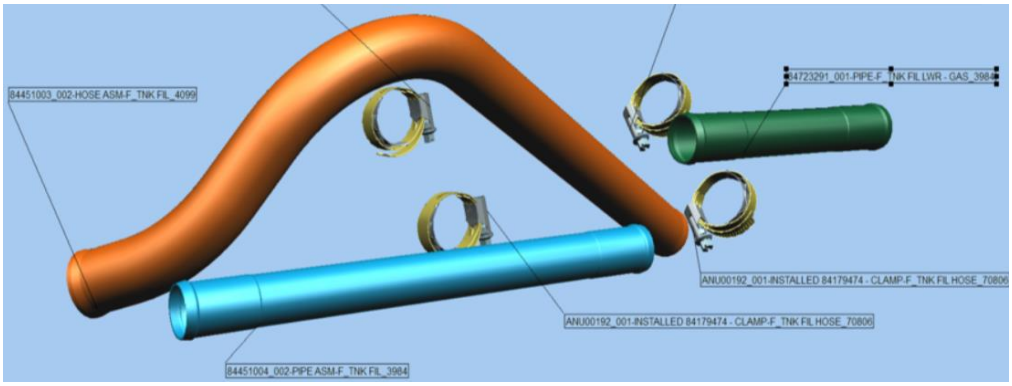
`Bag in Cab' Parts (below)

84451003_002-HOSE ASM-F_TNK FIL_4099
84723291_001-PIPE-F_TNK FIL LWR - GAS_3984
ANU00192_001-INSTALLED 84179474 - CLAMP-F_TNK FIL HOSE_70806
ANU00192_001-INSTALLED 84179474 - CLAMP-F_TNK FIL HOSE_70806
84451004_002-PIPE ASM-F_TNK FIL_3984

Use above ZW9 `GAS' `Bag in Cab' P/Ns (POA 84818645)

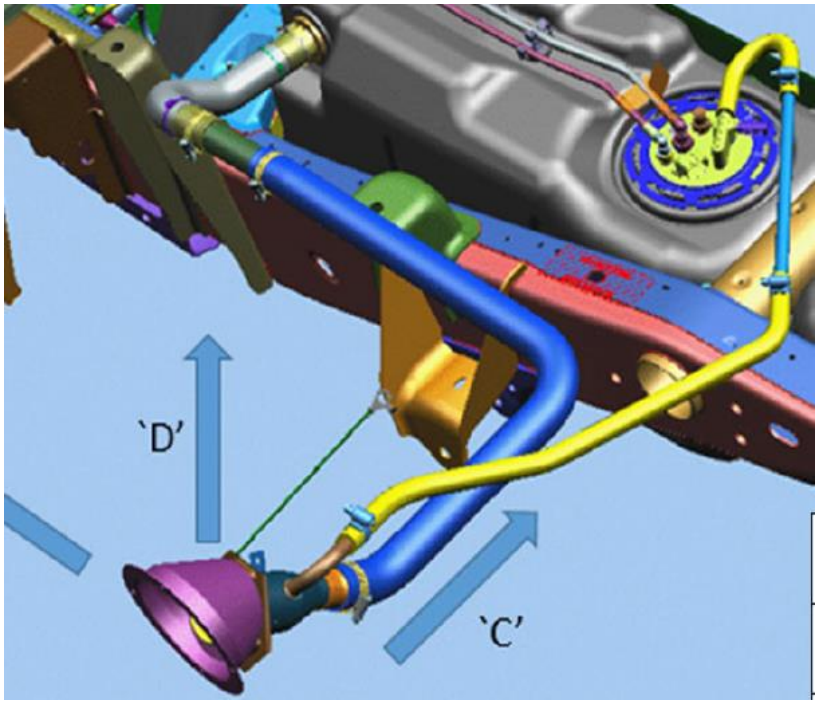
DIESEL PU Box Removal' GM Service Parts

84861894 HD Pickup ZW9 `DIESEL'(FHX) Fuel Fill Assembly (above)

DIESEL (FHX) *- Shown on Page 3*

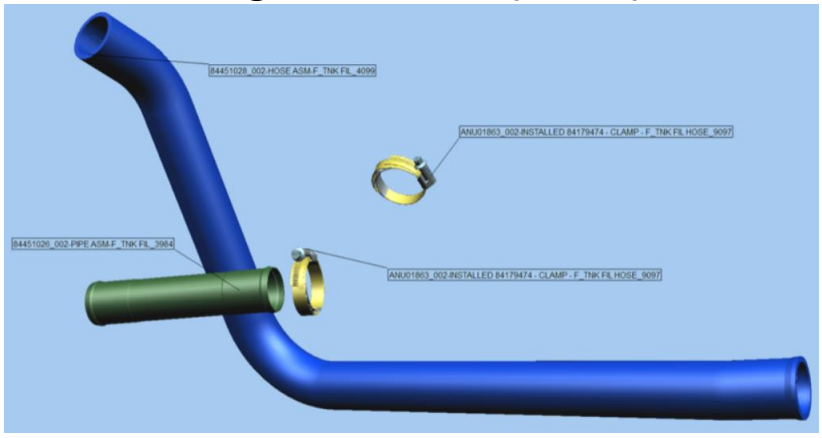
`Bag in Cab' Parts (below)

84451028_002:HOSE ASM:F_TNK FIL_4099
ANU01863_002:INSTALLED 84179474 : CLAMP : F_TNK FIL HOSE_9097
84451026_002:PIPE ASM:F_TNK FIL_3984
ANU01863_002:INSTALLED 84179474 : CLAMP : F_TNK FIL HOSE_9097

Use above ZW9 `DIESEL' `Bag in Cab' P/Ns (POA 84818644)
